TITLE:
**WETLAND SURFACE WATER
SAMPLE LOCATIONS**

REPORT:
FINAL BASELINE ECOLOGICAL RISK ASSESSMENT

SITE:
**GULFCO MARINE MAINTENANCE
FREEPORT, BRAZORIA COUNTY, TEXAS**

PROJECT: 41568745
DATE: MARCH, 2011

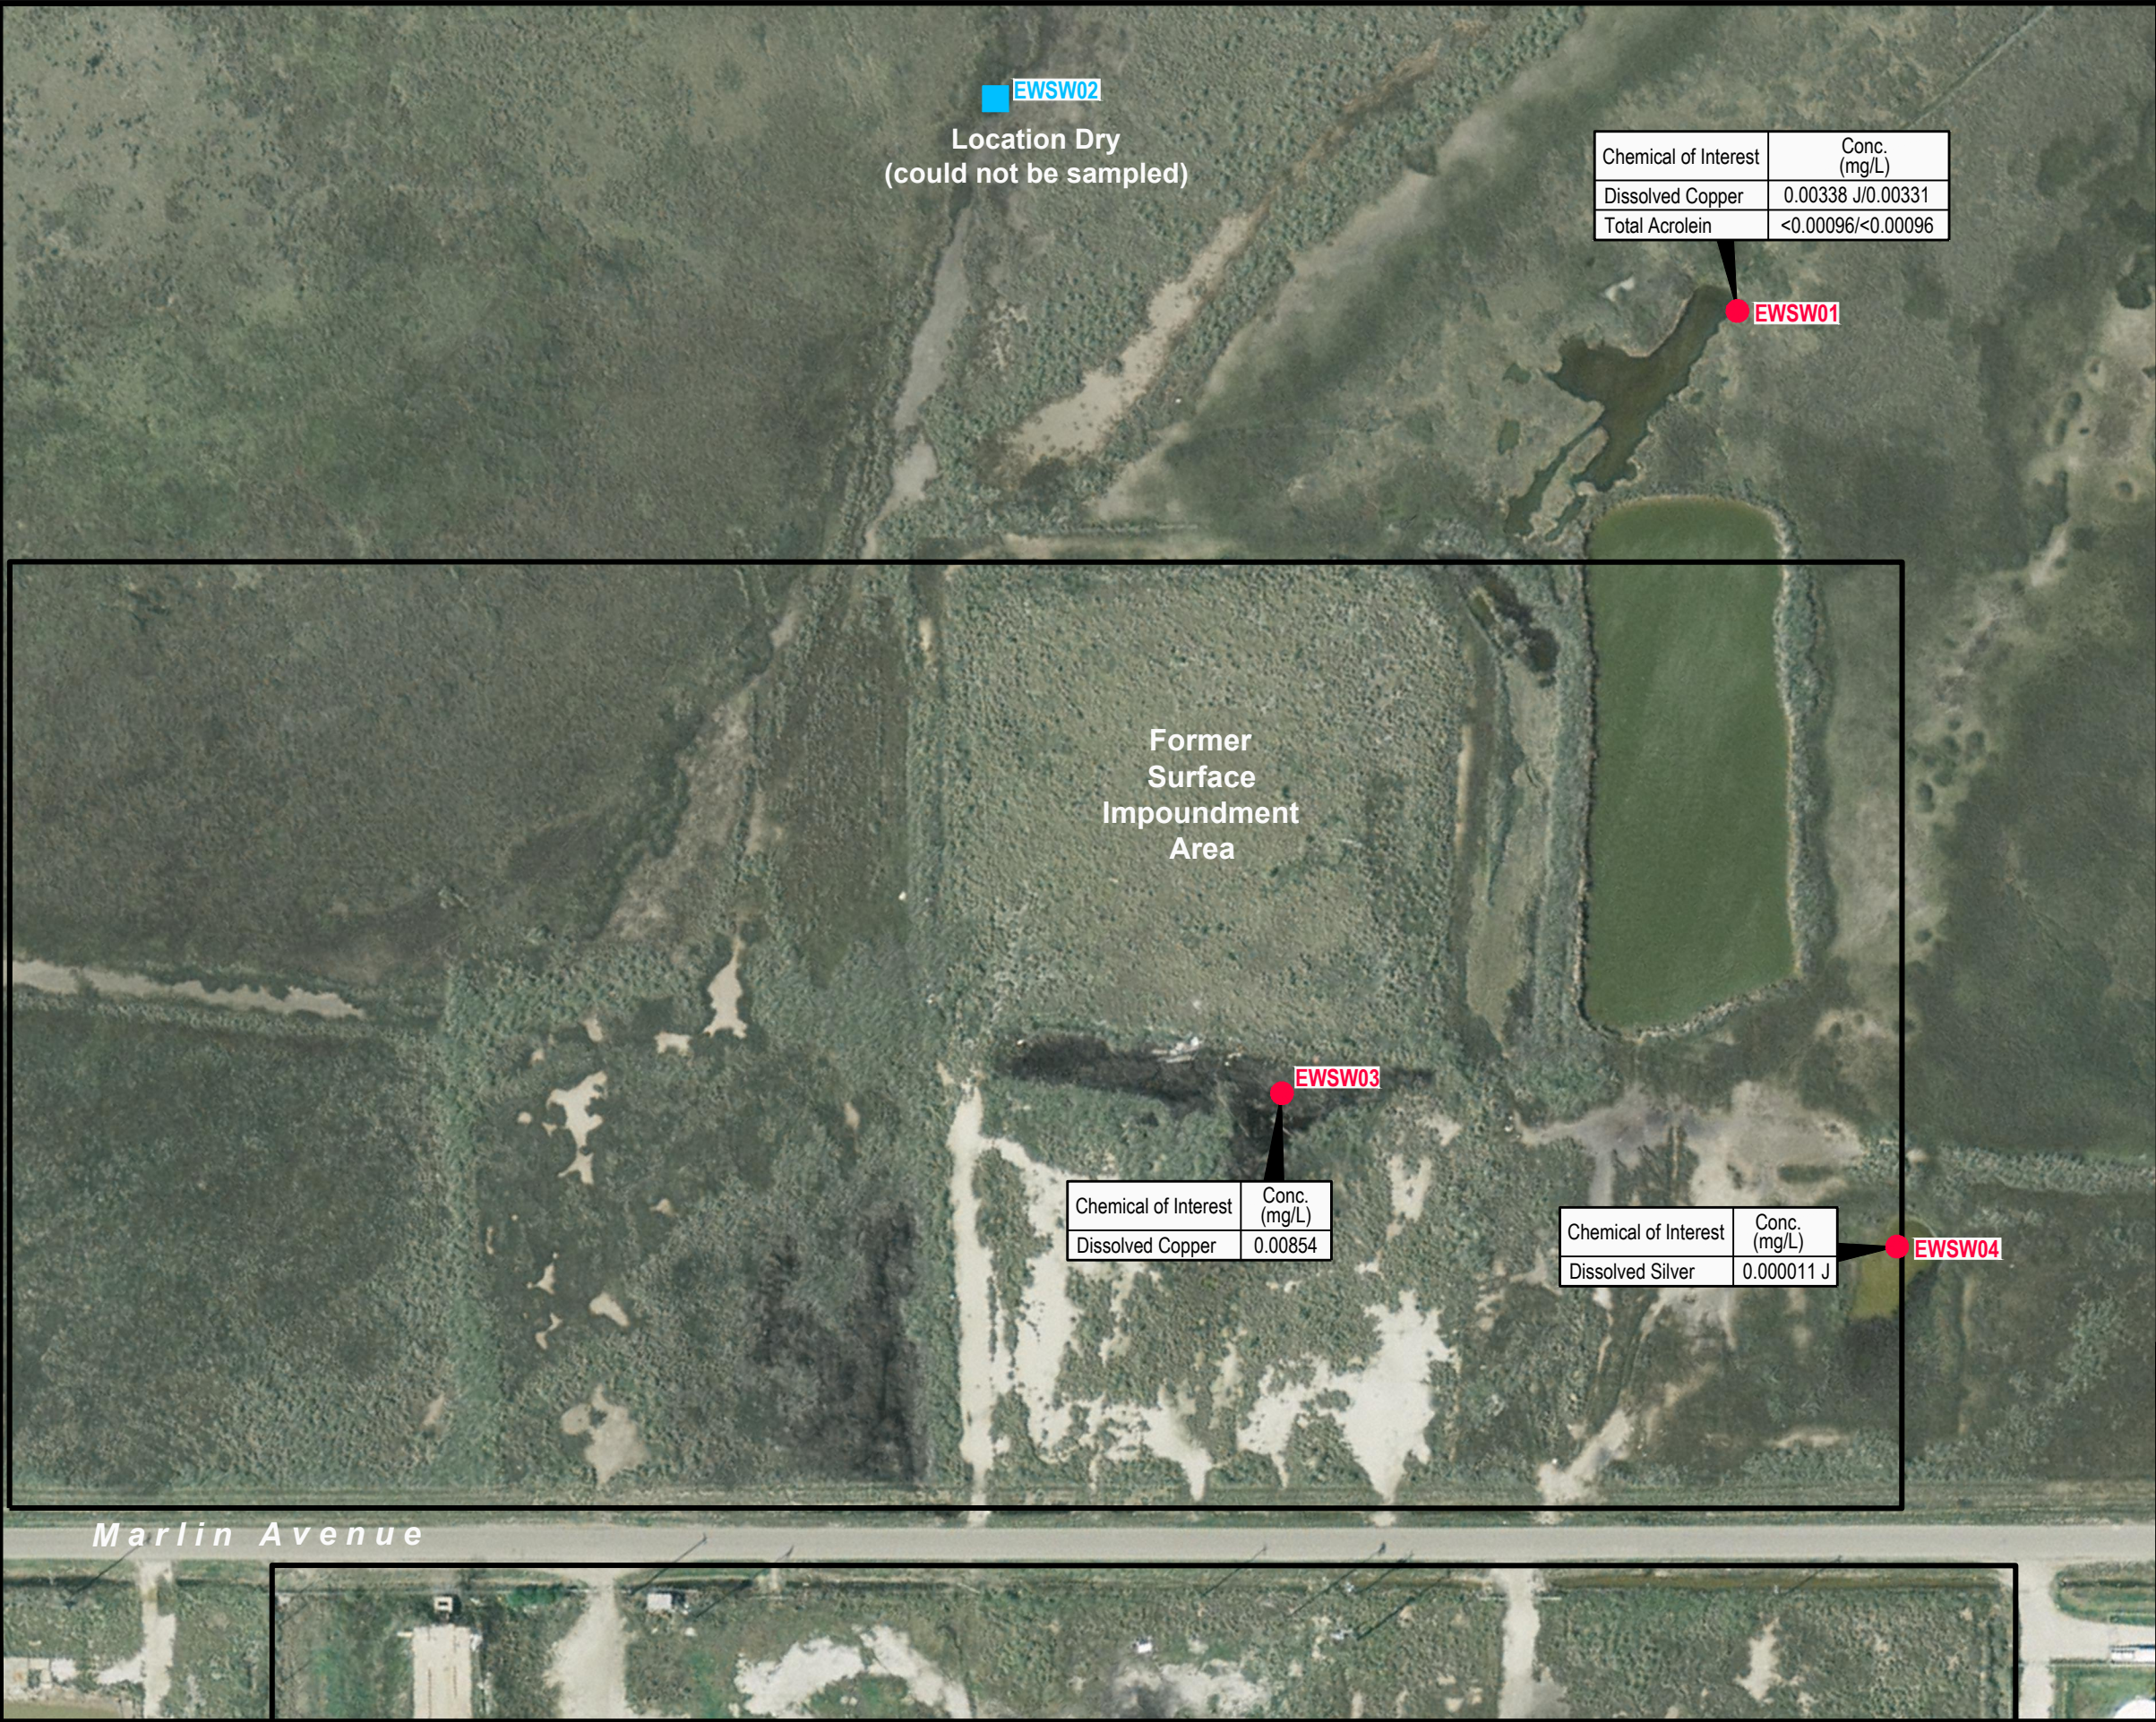
FIGURE:
7

EWSW02
Location Dry
(could not be sampled)

Chemical of Interest	Conc. (mg/L)
Dissolved Copper	0.00338 J/0.00331
Total Acrolein	<0.00096/<0.00096

Chemical of Interest	Conc. (mg/L)
Dissolved Copper	0.00854

Chemical of Interest	Conc. (mg/L)
Dissolved Silver	0.000011 J

- Gulfco Marine Maintenance Site Boundary (approximate)
- BERA Surface Water Sample Location
- BERA Surface Water Reference Sample Location

Notes
J - Estimated Value

All Concentrations in mg/L
